THE SPRING RESEARCH AND MANUFACTURERS' ASSOCIATION

THE EFFECTS OF OXIDE PENETRATION
ON THE FATIGUE PROPERTIES OF HEAVY
SPRINGS

Report No. 265

July 1976 .

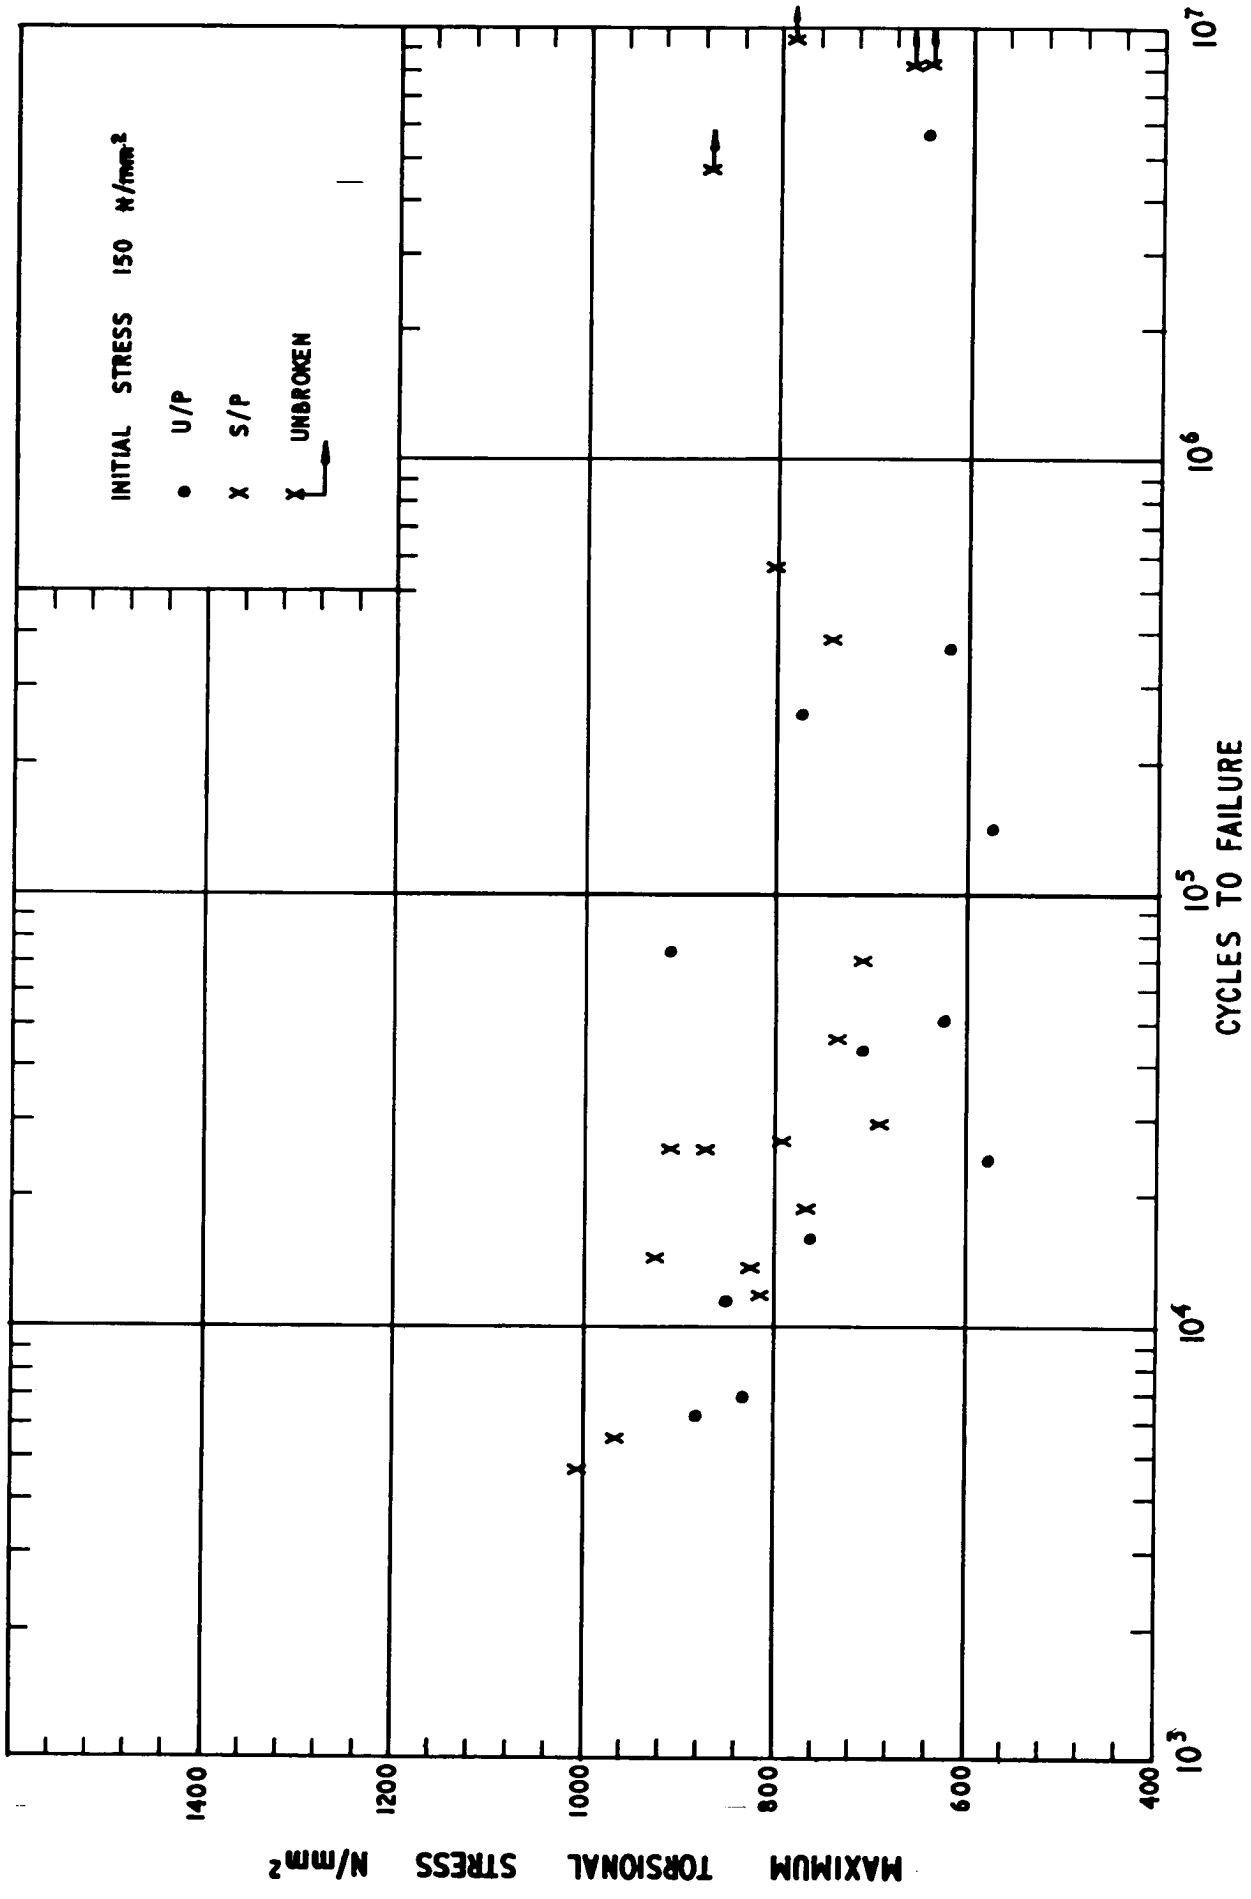
FIG. 1 FATIGUE DATA FOR GRADE 735A60 HOT COILED SPRINGS.

The results of the fatigue tests are shown in Figs. 1 to 3. In all cases there was a large amount of scatter in the results and it was found impossible to construct S/N curves from the experimental points.

Figs. 1 to 3 clearly demonstrate that no relationship exists between applied stress and endurance; indeed, no real distinction can be made between unpeened and shot peened springs. The performance of the springs under test was completely unpredictable and, had such springs been placed in service, would no doubt have led to justifiable complaints regarding poor fatigue performance.

As a point of interest, it can be seen from the data given in Figs. 1 and 2 that the introduction of a residual stress system at the surface by shot peening was in many cases inadequate to overcome the damage caused by oxide penetration. The application of a carbon restoration process would, of course, restore the carbon level at the surface but would not remove the damaging effects of the oxide penetration. If, however, the springs were then re-shot peened, the compressive stresses developed as has been shown in the literature⁽¹⁾ might be sufficient to transfer the position of maximum stress beyond the point at which the stress raising effects of oxide penetration are operative and some improvement in

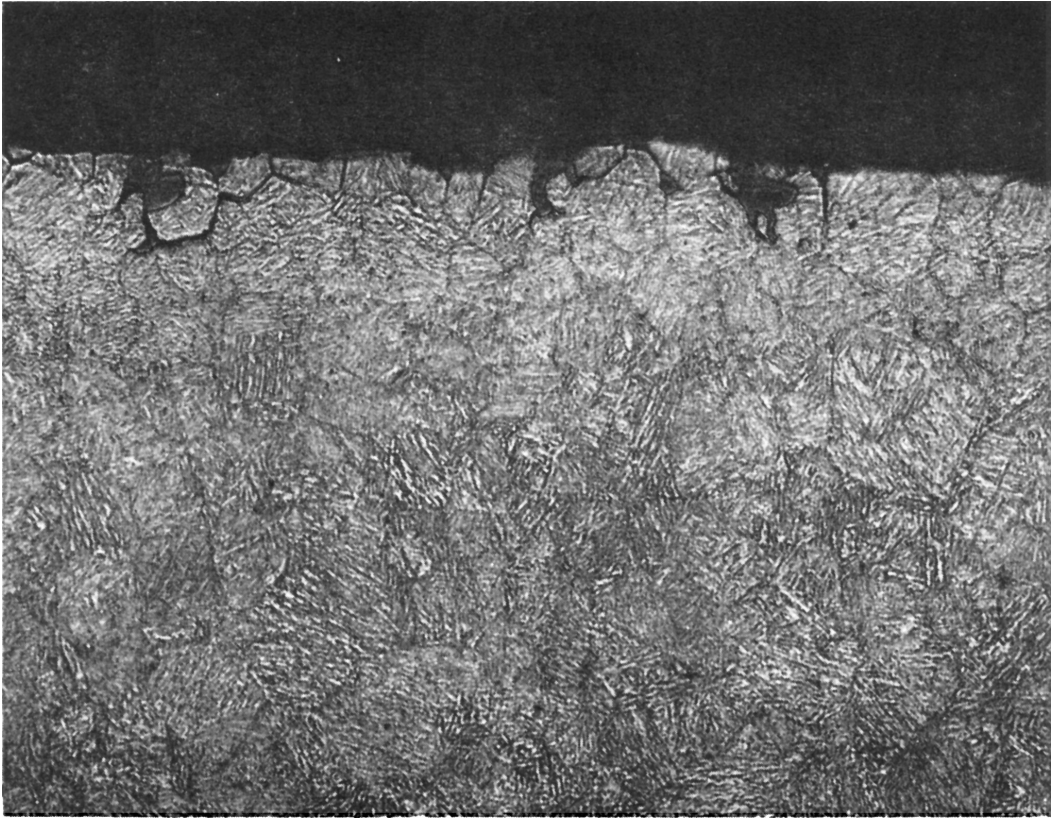
Fig. 4 shows a transverse microsection of an unpeened spring which was fatigue tested through a stress range of 450 to 895 N/mm² and failed after only 2,700 cycles. The fracture had initiated on the inside of the coil, extensive oxide penetration being present to a depth of approximately 0.1 mm. In some places oxide penetration had resulted in the formation of cracks during fatigue testing. The structure was tempered martensite throughout, which etched lighter towards the edges indicating a carbon gradient. Some grain boundary ferrite was also present near the edges, this partial decarburisation extending to a depth of approximately 0.05 mm. The hardness in the core of this section was 459 HV 30.

A number of springs were examined metallographically but only two examples are given here to demonstrate the great variation in structure and surface condition which can occur. It is evident that the spring which failed prematurely, illustrated in Fig. 4, had suffered severe oxide penetration, along with some decarburisation probably due to an excessively high coiling temperature and, maybe, prolonged time at some temperature above 1000°C. A coarse grain structure had resulted, again a reflection of the excessive temperature employed for the purpose of coiling and hardening.

Oxide penetration of the type illustrated would certainly provide severe stress raisers under dynamic stressing conditions, which would act as points for early initiation and growth of fatigue cracks, with consequent loss of overall fatigue performance. To a lesser extent the presence of a large grain size would also aggravate early failure.

FIG.4 Transverse microsection, Spring No. 30, x 185

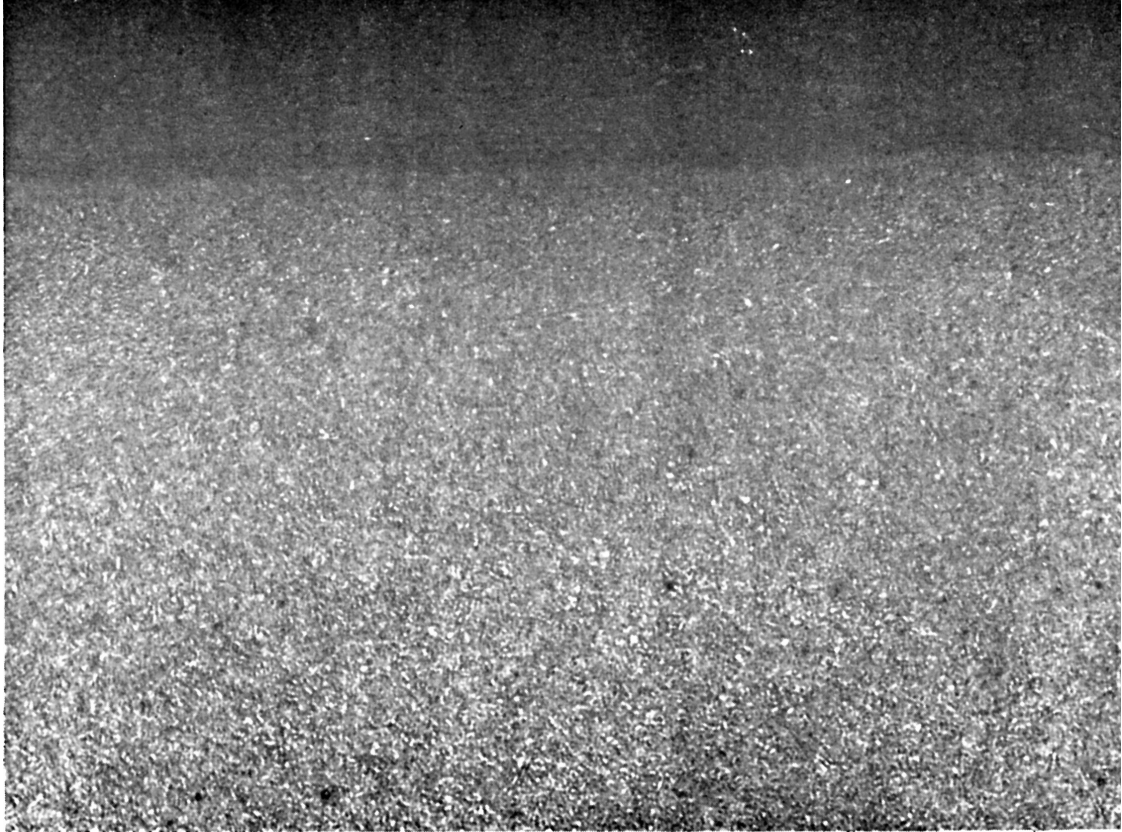
Fig. 5 shows a transverse microsection taken from an unpeened spring which failed after 440,000 cycles, an endurance more than 150 times greater than the previous spring, having been tested through a stress range of 450 to 925 N/mm². Again the origin of the fracture was at the point of maximum stress, on the inside of the coil. This spring contained no cracks, no significant oxide penetration and no carbon gradient. The structure was again tempered martensite but was much finer than that of the previous spring (Fig. 4). The hardness in the centre of the section was 451 HV 30.

FIG.5 Transverse microsection, Spring No. 56B, x 185
