FATIGUE FAILURES OF LIGHT SPRINGS

ON THE REASONS FOR SCATTER OF FATIGUE

Report No. 358

L. F. Reynolds, M.Sc.Tech., C.Eng., M.I.M.

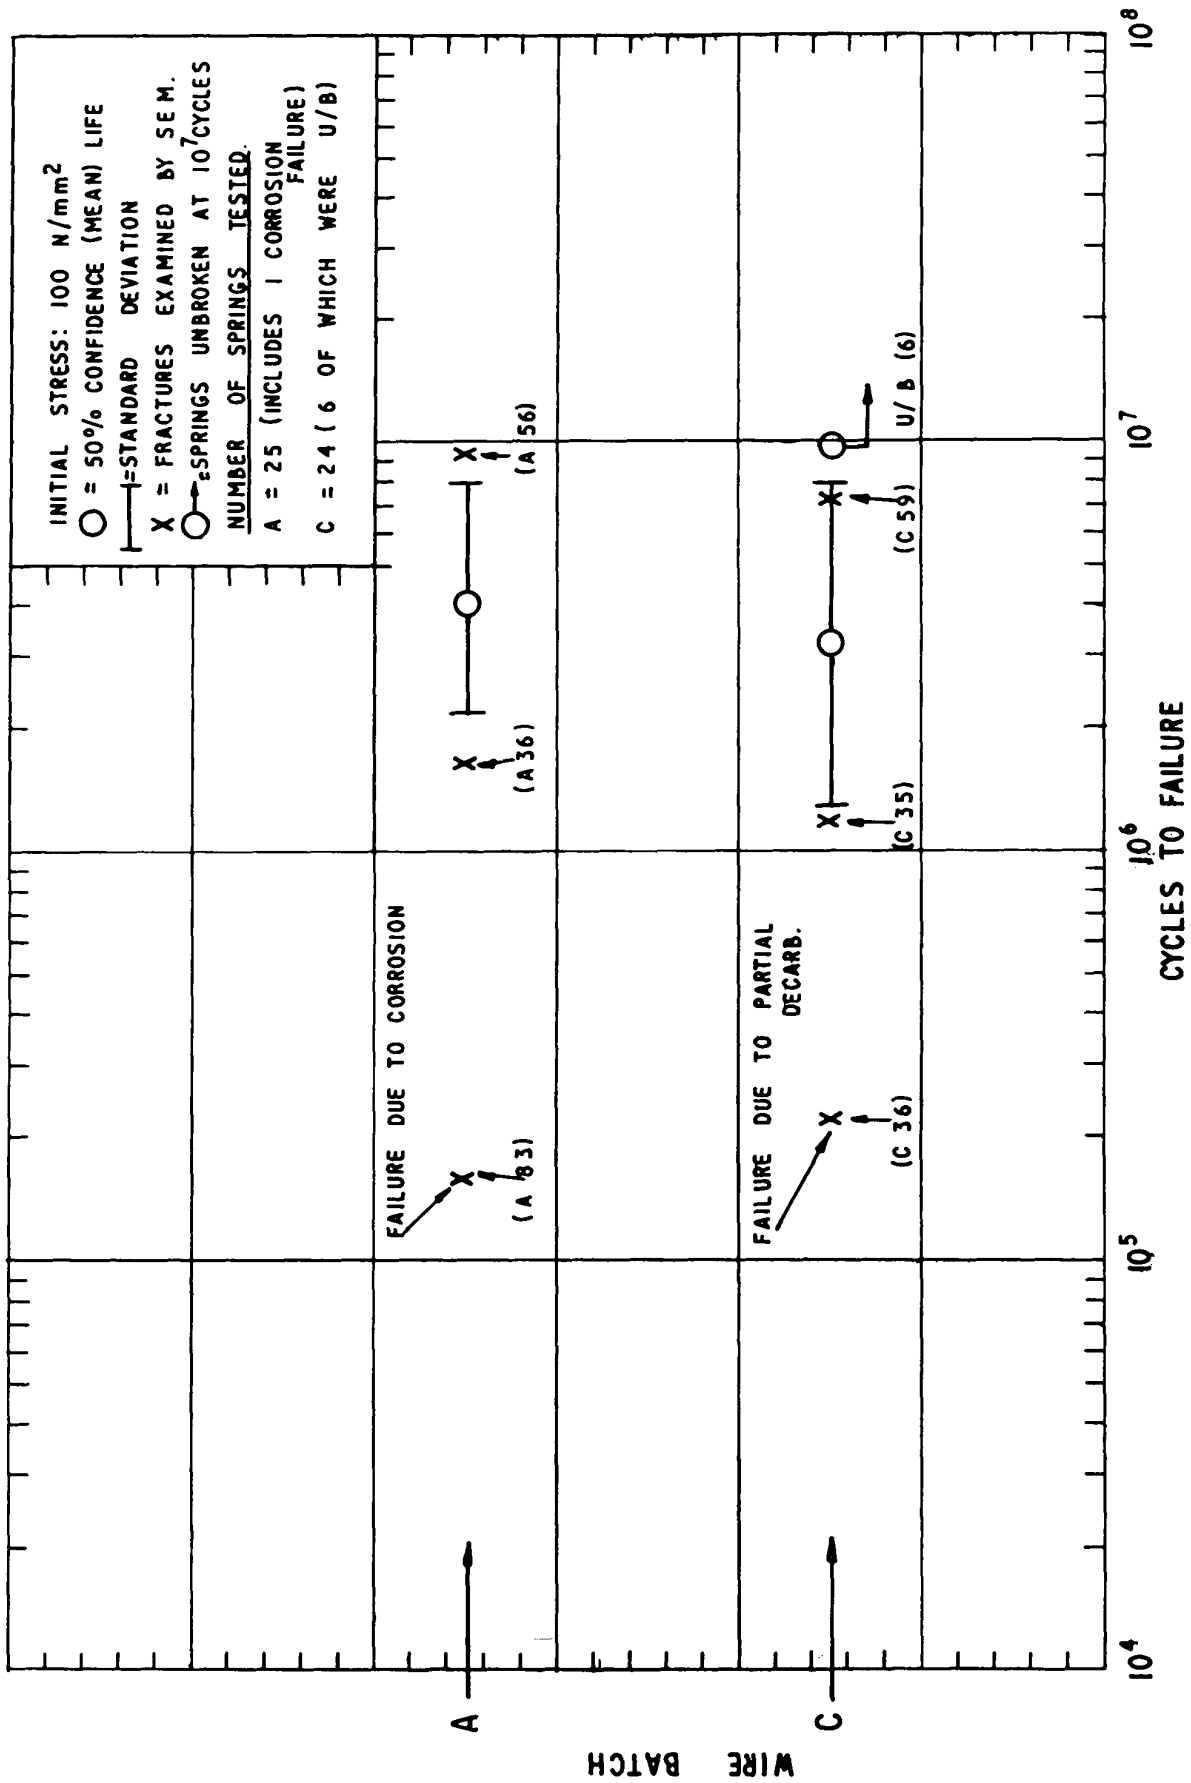
After omission of spring A83 (which failed prematurely to the influence of corrosion and is considered later in more detail), there was no statistically significant difference in either the mean life or the variance of the broken springs made from wires A and C.

Furthermore, the range shown for springs made from Wire Batch C was a conservative estimate, since 6 of the 24 springs tested remained unbroken after 10^7 cycles (implying that the fatigue limit of the Batch C springs may have been higher than that of the Batch A springs), whilst 2 springs failed at lives of less than 10^6 cycles.

FIG. 2. FATIGUE OF BS 5216 ND3 COMPRESSION SPRINGS: MAXIMUM STRESS 750 N/mm²

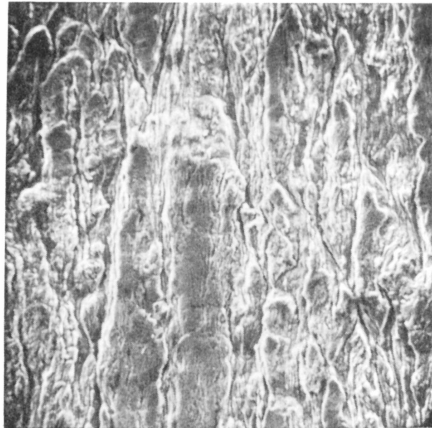
Fig 4 x 340
Wire A

The results of SEM examination are shown in Figs. 4 and 5 for Wire A and Wire C respectively. The wire surfaces were typical of those previously observed at S.R.A.M.A. for very similar material, and detailed investigations have shown that the apparent differences in surface roughness do not exert a significant influence on the fatigue performance of springs made from the wires⁽³⁾.

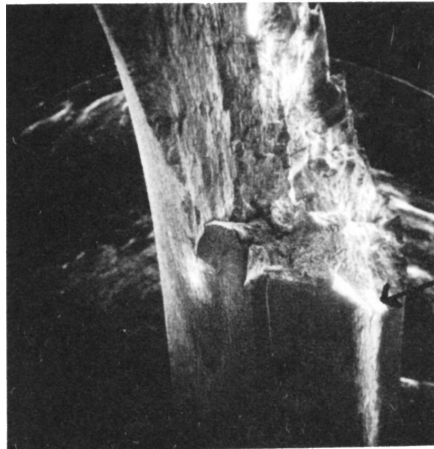
A more detailed examination of the fracture surface was carried out using a Scanning Electron Microscope with an analytical attachment. This examination indicated that both sodium and chlorine were present at regions of the spring surface associated with the crack origin, thus suggesting that the short fatigue life was associated with saline (NaCl) contamination at the spring surface.

Sample "charging up" due to surface contamination

Fig 25 x 14
General appearance of fracture initiation due to corrosion, close to inside of spring coil

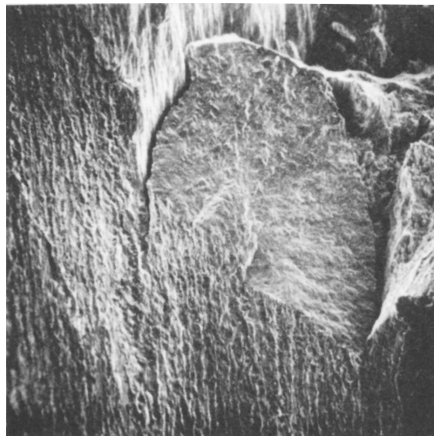
Fig 26 x 70
Fracture initiation in more detail

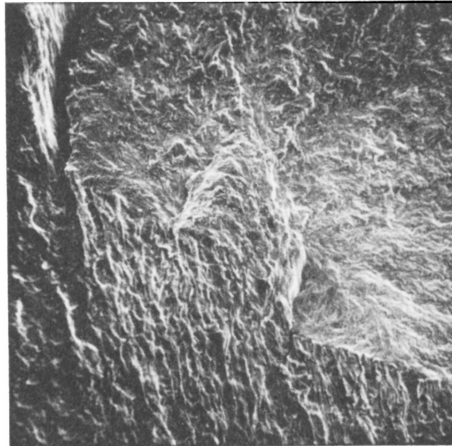
Fig 27 x 140
More detail of fracture
initiation. Note absence
of longitudinal shear
(Stage I) crack

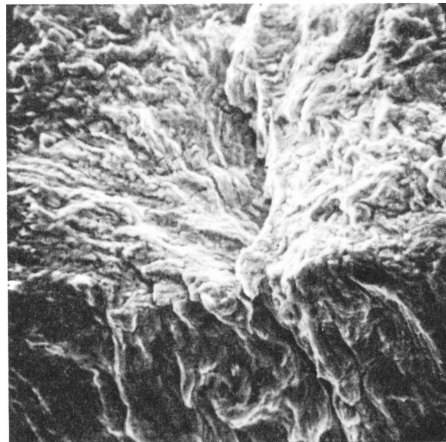
Examination on the SEM showed that Stage I (shear) crack propagation was completely absent in this spring, the fatigue crack having proceeded directly into the Stage II (45° tensile) mode of propagation from the inside surface of the coil (see Fig. 28).

Fig 28 x 690
Detail of fracture
initiation confirming that
failure commenced in 45°
tensile mode (Stage II)
at the spring surface

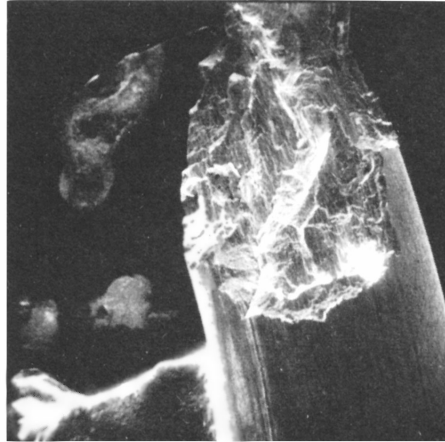
Fig 29 x 13
General appearance of
fracture initiation close
to inside of spring coil.

Mechanical damage
at fracture
surface.

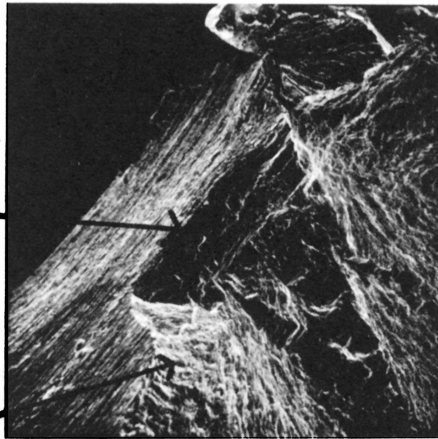
Scanning electron microscopy clearly established that both Stage I and Stage II regions of crack propagation were involved in fatigue failure of this spring (see Fig. 31).

Sample re-oriented to show
shear fracture and tensile
fracture more clearly.

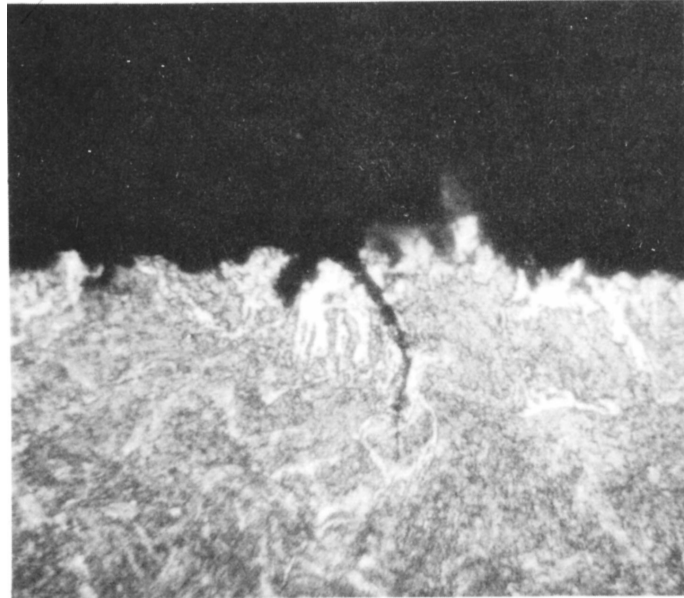
After etching in 2% Nital, it became apparent that partial decarburization was present to a depth of 0.025 mm at the regions of the spring associated with the fatigue crack origin. Furthermore, several examples were observed of longitudinal shear (Stage I) fatigue cracks propagating along the ferrite "spines" at these areas of partial decarburization (see Fig. 33).

Consequently crack initiation and Stage I (shear) crack propagation probably occurred relatively quickly in spring C36, leading to early transition into Stage II (tensile) propagation and subsequent rapid failure of the spring.

The fact that this spring experienced early failure as a direct result of surface decarburization indicates that this aspect of the fatigue behaviour must be considered an intrinsic feature of the fatigue properties of springs containing the observed levels of partial decarburization.

Fig 33 x 1060
Longitudinal shear (Stage I) fatigue
crack initiated at region of partial
decarburization in spring C36, which
experienced early failure at 2.2×10^5
cycles.

It is suggested that shot peening the springs will eliminate such early failures, but that further investigation is required to identify the defect levels below which such early failures can be avoided.
