THE EFFECT OF SURFACE ROUGHNESS, ELECTROPOLISHING AND SHOT PEENING ON THE FATIGUE PROPERTIES OF AUSTENITIC STAINLESS STEEL SPRINGS

Report No 369

THE SPRING RESEARCH AND MANUFACTURERS' ASSOCIATION

MARCH 1984

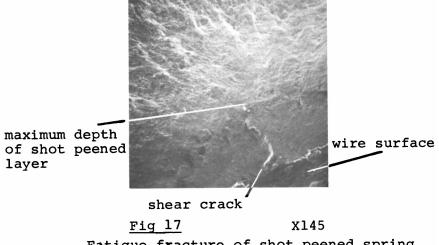
The few failures which had occurred in the shot peened springs had all initiated at the wire surface with the standard stage I longitudinal shear crack which had then propagated through the shot peened surface layer prior to transferring to stage II failure. This is clearly demonstrated in Figure 17, where the depth of the shot peened layer is easily identifiable and was found to extend to a depth of approximately 0.13 mm.

Fatigue fracture of shot peened spring
