THE SPRING RESEARCH AND MANUFACTURERS' ASSOCIATION

PROBLEMS ASSOCIATED WITH ELECTROPLATED
SPRINGS

Report No. 405

DECEMBER 1986

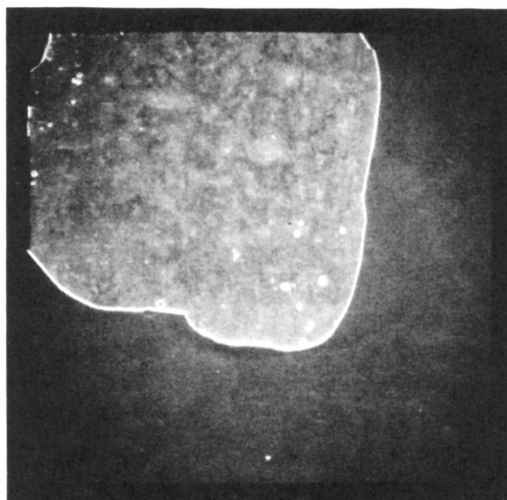
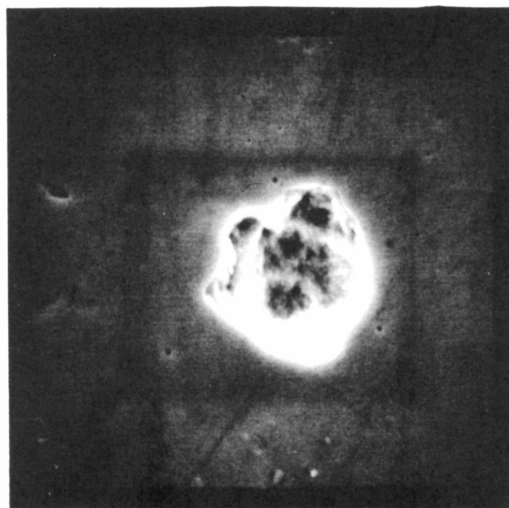
The steel surface beneath the blisters was examined on the scanning electron microscope. Numerous pits were present in the steel surface at these locations, as shown in Figs 1 and 2. Subsequent enquiries revealed that, prior to plating, one of the pre-cleaning operations involved a room temperature pickle in uninhibited 50% hydrochloric acid.

The steel surface was severely pitted by a 50% hydrochloric acid pickle, leading to poor adhesion and blistering of the nickel during electroplating.

Fig 1 X 110
General view of corrosion
pits at steel surface
underneath nickel blister

Fig 2 X 2820
Detail of corrosion pit
at steel surface underneath
nickel blister

Springs should not be pickled in 50% hydrochloric acid. Preliminary surface preparation can be accomplished using alkaline or anodic cleaning techniques, as specified in DEF 03-2 for example. Subsequent acid cleaning should be carried out in hydrochloric acid solutions not exceeding 20% concentration, and suitable inhibitors should be used to minimise chemical attack of the steel surface during acid cleaning.

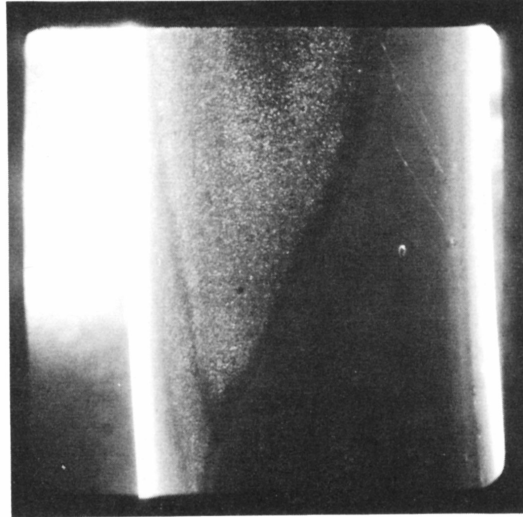
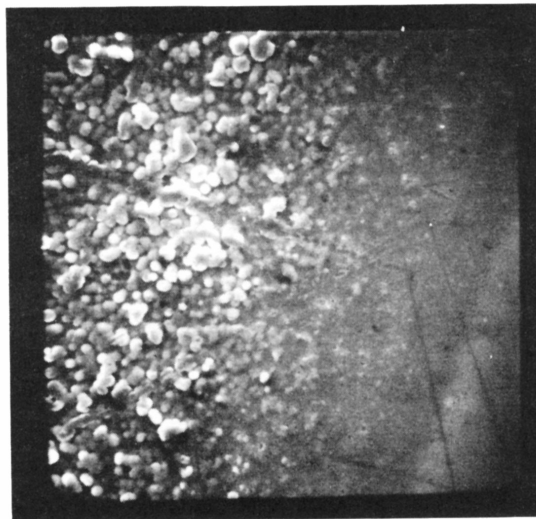
The dull areas had a coarse granular appearance (Figs 3 and 4).

The defects suggest that the plating baths were contaminated with suspended material.

Fig 3 X 70

View of dull area on bright nickel plated surface.

Fig 4 X 1440

Detail of adjacent dull/
bright nickel areas

The problems can be corrected by correct pre-cleaning, bath maintenance and filtration procedures for bright nickel plating.

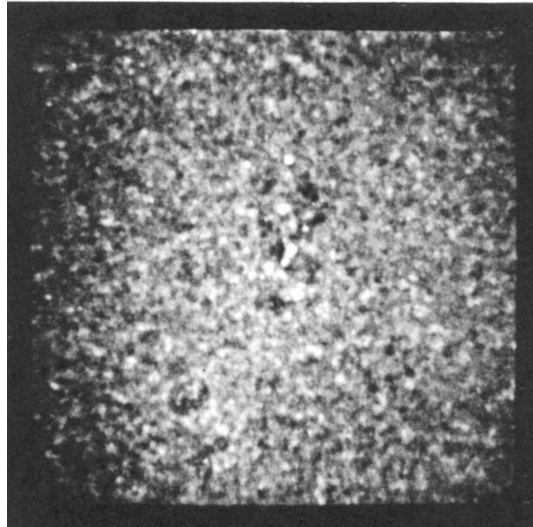
The discoloured areas also exhibited a granular appearance, but the granularity was much finer than that of the dull plated areas (Fig 5).

Fig 5 X 2760
Detail of brown/purple
discoloured area on nickel
plated surface.

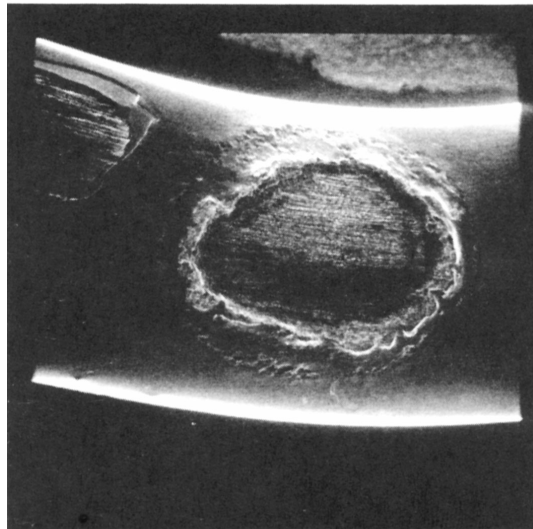
A typical unplated zone is shown in Fig 6. The unplated wire surface was clearly visible at the bottom of a wide, shallow pit in the nickel plate.

The wide, shallow pits may have resulted from organic contamination of the bath, or from incomplete solution of an organic leveller such as Coumarin during the plating process.

Fig 6 X 60
Unplated area which was
associated with red/brown
greasy deposit.

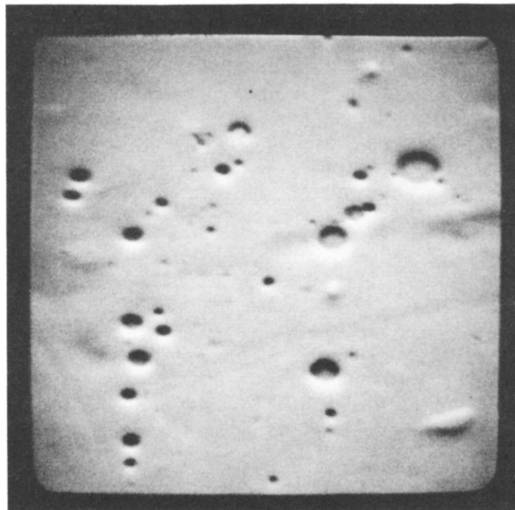
Scanning electron microscopy revealed numerous pits in the nickel plate on the concave spring surface, as shown in Fig. 7. Many of the pits were very small, being less than 0.0005mm in diameter.

Relatively poor throwing power during bright nickel plating gave a slower rate of nickel deposition at the concave surface. The resulting plate at this location was too thin to completely cover the steel surface, leaving numerous small pits in the nickel deposit. The plating solution in the pits was not completely removed during washing, resulting in the development of spotting stains on the plated springs.

Fig 7 X 5100
Detail of pits in nickel
plate at area of thin deposit

The springs should be nickel plated to give a minimum thickness of at least 0.01 mm nickel at the concave surface.

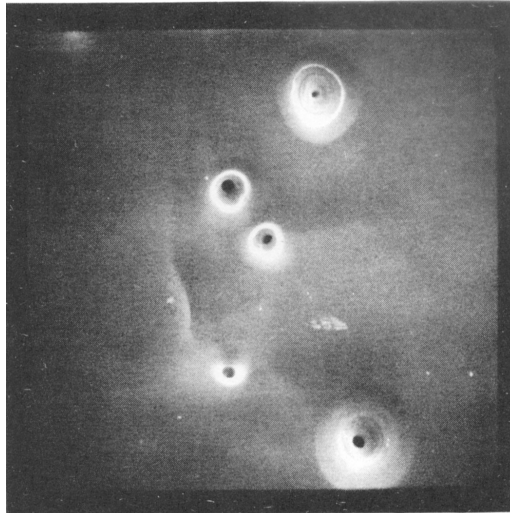
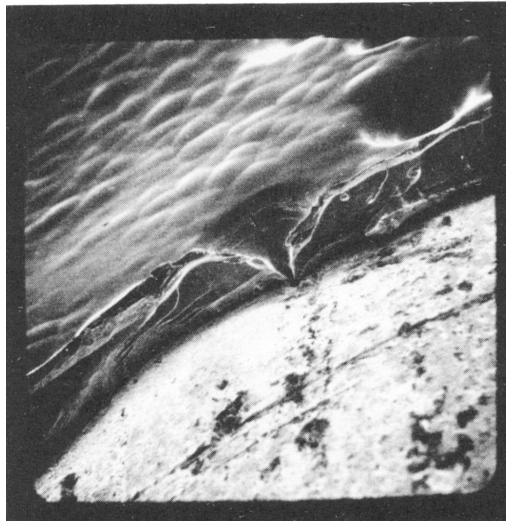
Scanning electron microscopy revealed that the pits extended completely through a very thick chromium deposit, as shown in Figs 8 and 9. More detailed examination indicated that the pits in the chromium plate initiated at small intrusions in the steel surface, as shown in Fig 10. These findings were verified by optical microscopy, which confirmed that gas pitting of the chromium plate was initiated by 0.035mm deep intrusions in the steel wire surface, as shown in Fig 11. Optical microscopy further showed that the chromium plate was 0.09mm thick, which is substantially greater than the 0.0002-0.002mm deposit normally used for bright chromium plate.

Hydrogen pitting of the chromium plate was initiated at intrusions in the drawn mild steel surface.

Gas pitting was further accentuated by a chromium layer which was approximately 0.09mm thick.

Fig 8 X 145
General view of pits in chromium plate

Fig 9 X 130
View of pit at area of fractured chromium plate

Similar gas pitting can be avoided by copper flashing, and then bright nickel plating the parts in a bath with good levelling action to give a minimum nickel thickness of 0.01mm.

A final chromium coating of 0.0002-0.002mm will provide the bright finish required for decorative applications.

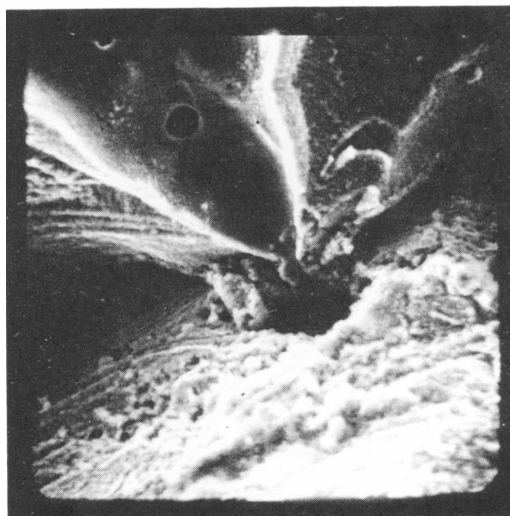
Fig 10 X 1320
Initiation of pit in chromium plate at intrusion on steel surface

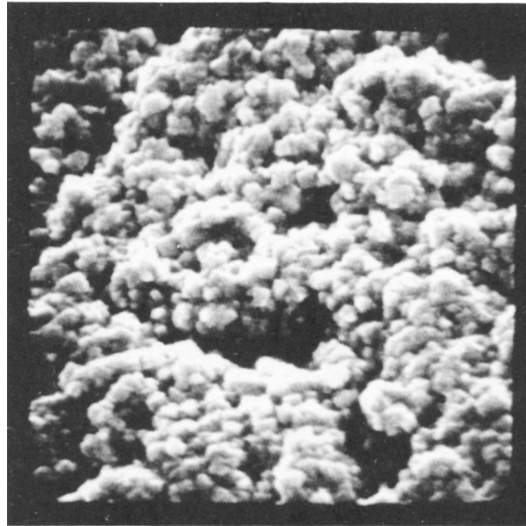
Examination of the open coiled area of dull chrome revealed the granular chromium normally associated with a burned deposit, as shown in Fig 13.

The dull chromium most probably resulted from a locally high current density at the open coiled zone of the spring.

Fig 13 X3200

Detail of burned chromium plate at open coiled area of spring.

A burned chromium deposit can be avoided by careful control of the voltage applied during chromium plating. In particular, components exposing a variable surface area to the plating solution will require careful control of the chromium plating process.

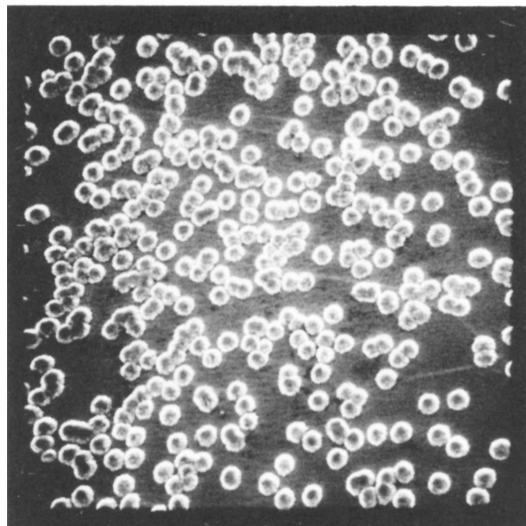
The bright chrome area merged gradually with the burned area, as indicated by the appearance of an intermediate zone shown in Fig 14.

Fig 14 X 330

Transition zone of bright/burned chromium plate at open coiled area of spring

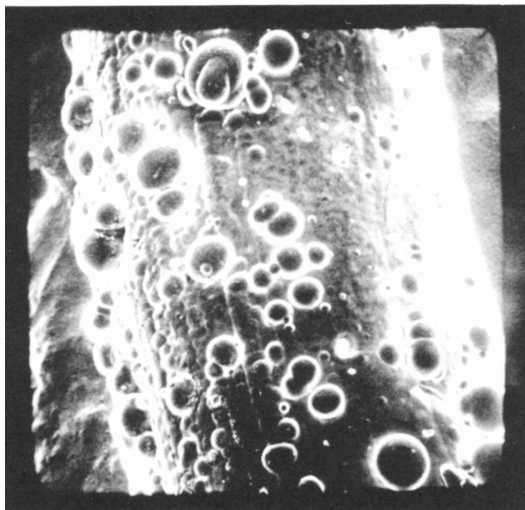
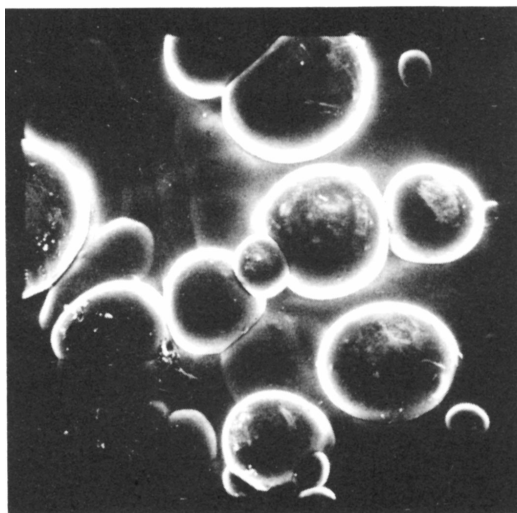
Examination on the scanning electron microscope revealed a very granular zinc coat of uneven distribution, as shown in Figs 15 and 16. Optical microscopy confirmed that the zinc was very unevenly distributed, with a deposit thickness varying between 0-0.15mm. Approximately 50% of the spring surface was not coated with zinc at all.

The granular appearance and poor distribution of the zinc suggests that the spring was plated in a bath low in metal/cyanide/hydroxide. The plating current may also have been higher than that normally employed for bright zinc electroplating.

General appearance of granular plate

Detail of granular plate

Improved process control during plating will ensure that the bath composition, temperature and plating current remain in balance for bright zinc electroplating.

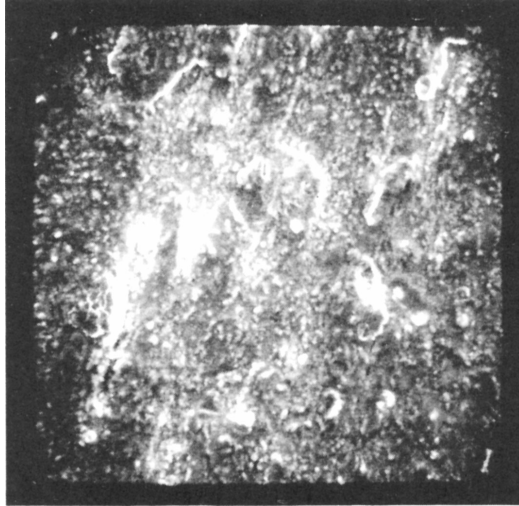
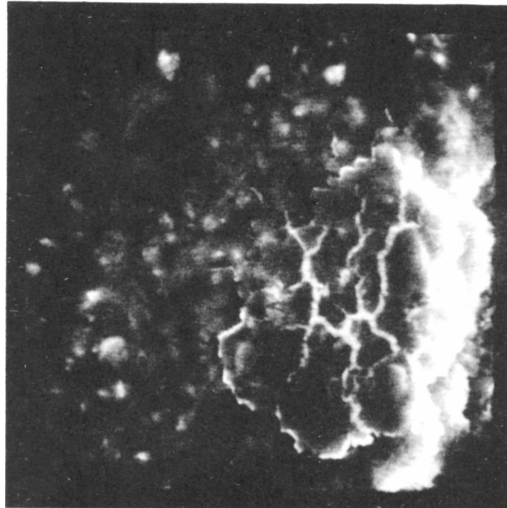
Examination on the scanning electron microscope revealed a lightly roughened zinc surface with some evidence of nodular zinc growth, as shown in Figs 17 and 18. Optical examination revealed an evenly distributed zinc deposit with a thickness of 0.02mm.

The combination of fine scale roughness and nodular zinc growth suggests that the plating solution was both out of balance and contaminated with suspended solids, possibly from anode sludge, dust etc.

Fig 17 X 600
General appearance of rough
plate

Fig 18 X 3000
Detail of rough plate
showing nodular growth.

Improved process control and filtration during plating will give the required bright zinc finish.

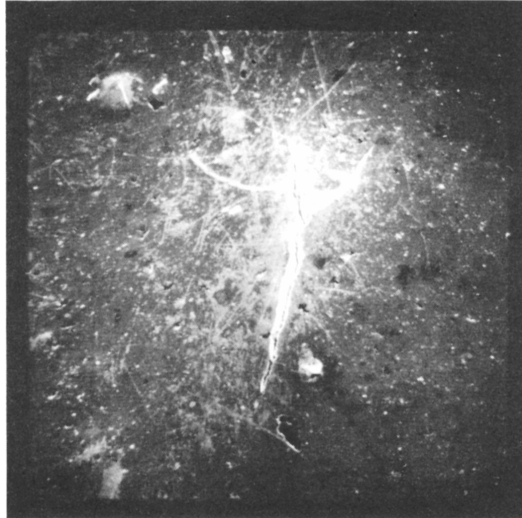
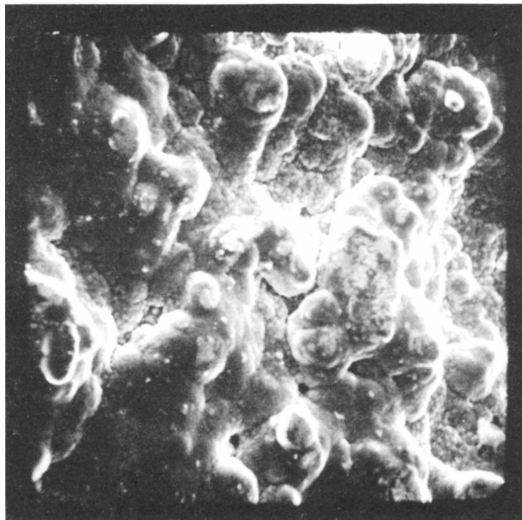
Examination on the scanning electron microscope revealed a severely cracked and blistered zinc plate, as shown in Fig. 19.

More detailed examination showed the zinc to exhibit a marked nodular character, as shown in Fig 20.

The nodular/blistered character and duplex nature of the zinc plate suggests that an unbalanced bath composition and poor process control was the cause of this plating problem.

Fig 19 X 110
General appearance of low
adhesion plate

Fig 20 X 600
Detail of nodular deposit
on low adhesion plate.

Improved process control and attention to the bath composition during plating should eliminate the problem.

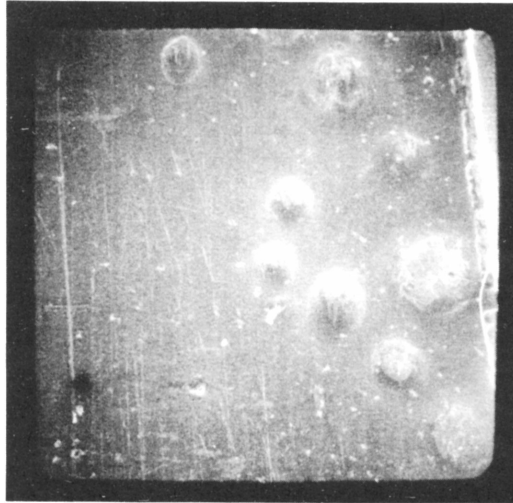
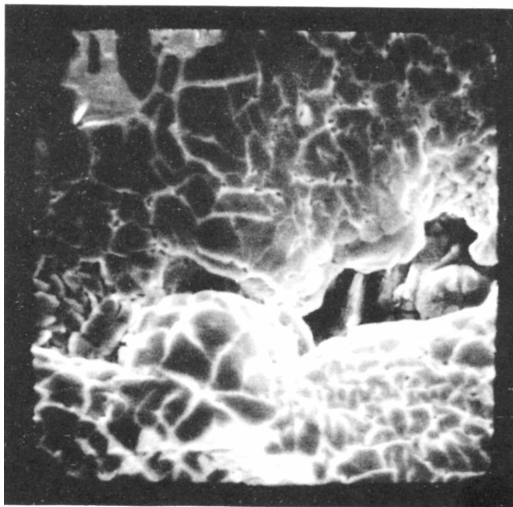
The sample was examined on the scanning electron microscope and the general appearance of the bubbled zone is shown in Fig 21.

Detailed examination of the bubbled areas showed clear evidence that the cadmium plate was broken up by hydrogen gassing, as shown in Fig 22. (The grain boundary effect in Fig 22 is due to chromate passivation of the cadmium).

It is likely that an acid cleaning process and/or insufficient washing, prior to plating, was the main cause of the gassing problem.

General view of blistered
cadmium plate

Detail of porous cadmium
plate at blistered zone.

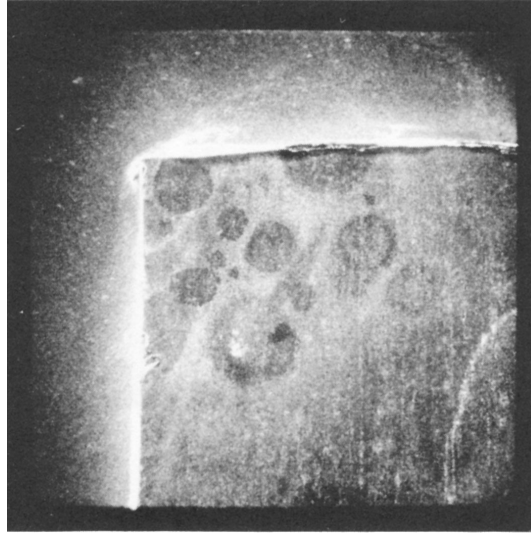
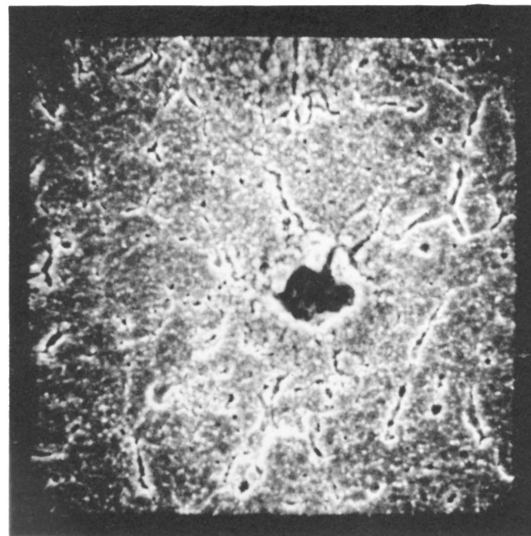
Removal of the cadmium in 30% ammonium nitrate solution, to expose the steel surface, revealed that the bubbled areas were characterized by a surface texture markedly different to that of the unbubbled surface, as shown in Fig 23. More detailed examination showed that corrosion pits were present within each area of the steel associated with bubbling of the cadmium plate, as shown in Fig. 24. This scanning electron micrograph also indicates that the grain boundaries of the austempered steel were well delineated as if by acid attack.

Although the grain boundary attack was present over all the steel surface, it was particularly marked at the bubbled areas.

Fig 23 X 25
General appearance of steel
surface at blistered area

Fig 24 X 1020
Detail of corrosion pit and
grain boundary attack on
steel surface at blistered
area.

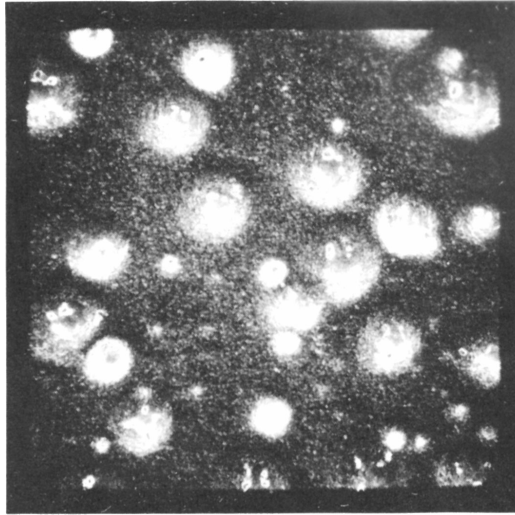
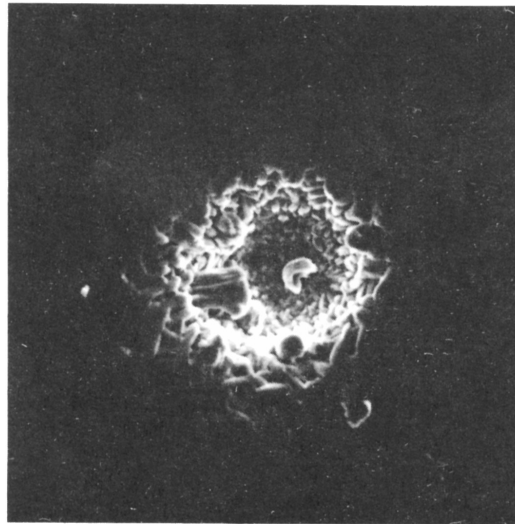
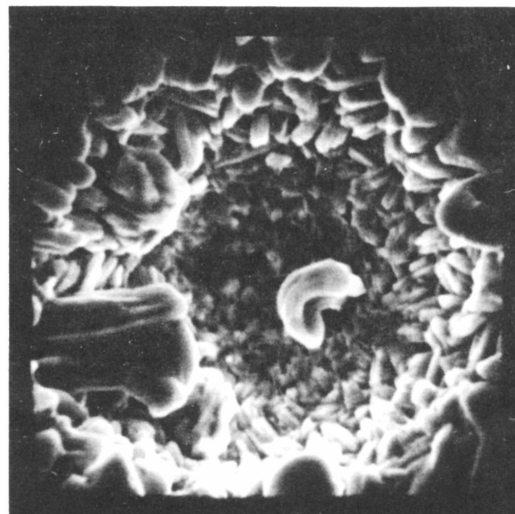
Fig 25 X 110
General appearance of
numerous pits in cadmium
plate

Fig 26 X 1080
Typical pit in cadmium plate

Fig 27 X 2640
Detail of pit showing debris
particle which initiated
defect.

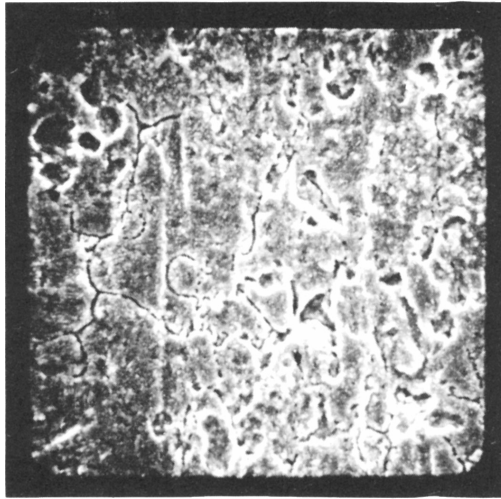
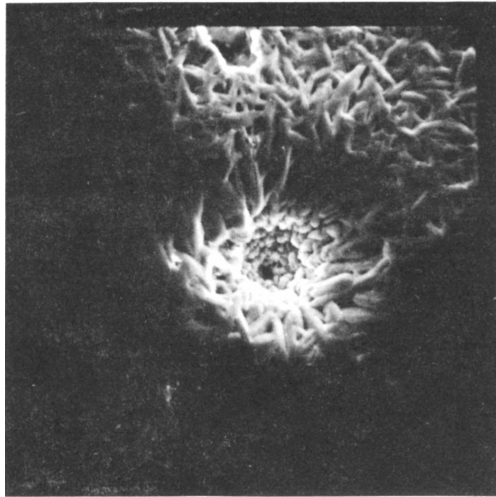
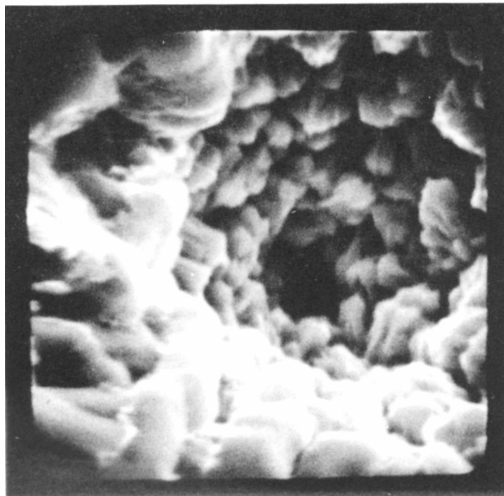
Fig 28 X 1080
Satisfactory steel surface revealed after cadmium plate removed.

Fig 29 X 1080
Typical pit in cadmium plate after debris particle removed.

Fig 30 X 5400
Detail of bottom of pit in cadmium plate, showing position previously occupied by debris particle which initiated defect.

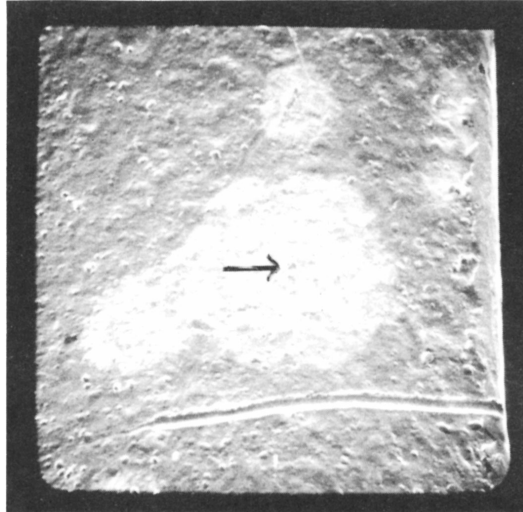
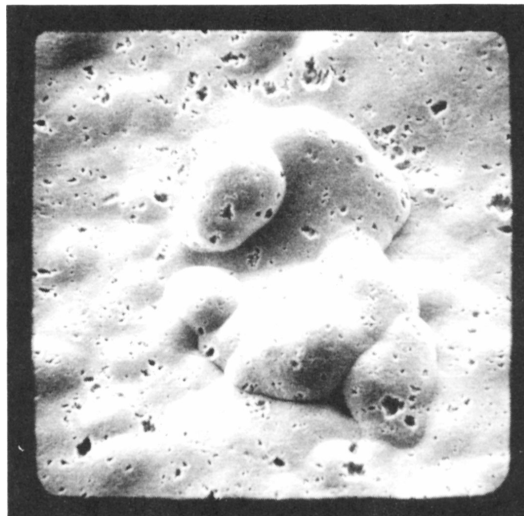
The granular and porous cadmium deposit retained cyanide solution in the crevices after the final washing operation. During storage, the retained cyanide seeped out onto the cadmium surface to give the observed brown "spotting" effect.

Fig 31 X 33
Area of brown spotting stain
on cadmium plate

Fig 32 X 515
Detail of granular deposit
at centre of spotted zone
above (arrowed). Note also
porosity of plate.
