THE SPRING RESEARCH AND MANUFACTURERS' ASSOCIATION

Decarburisation/Defects and their
effect on the dynamic properties
of springs made from spring wire.

Report No. 377

January 1985

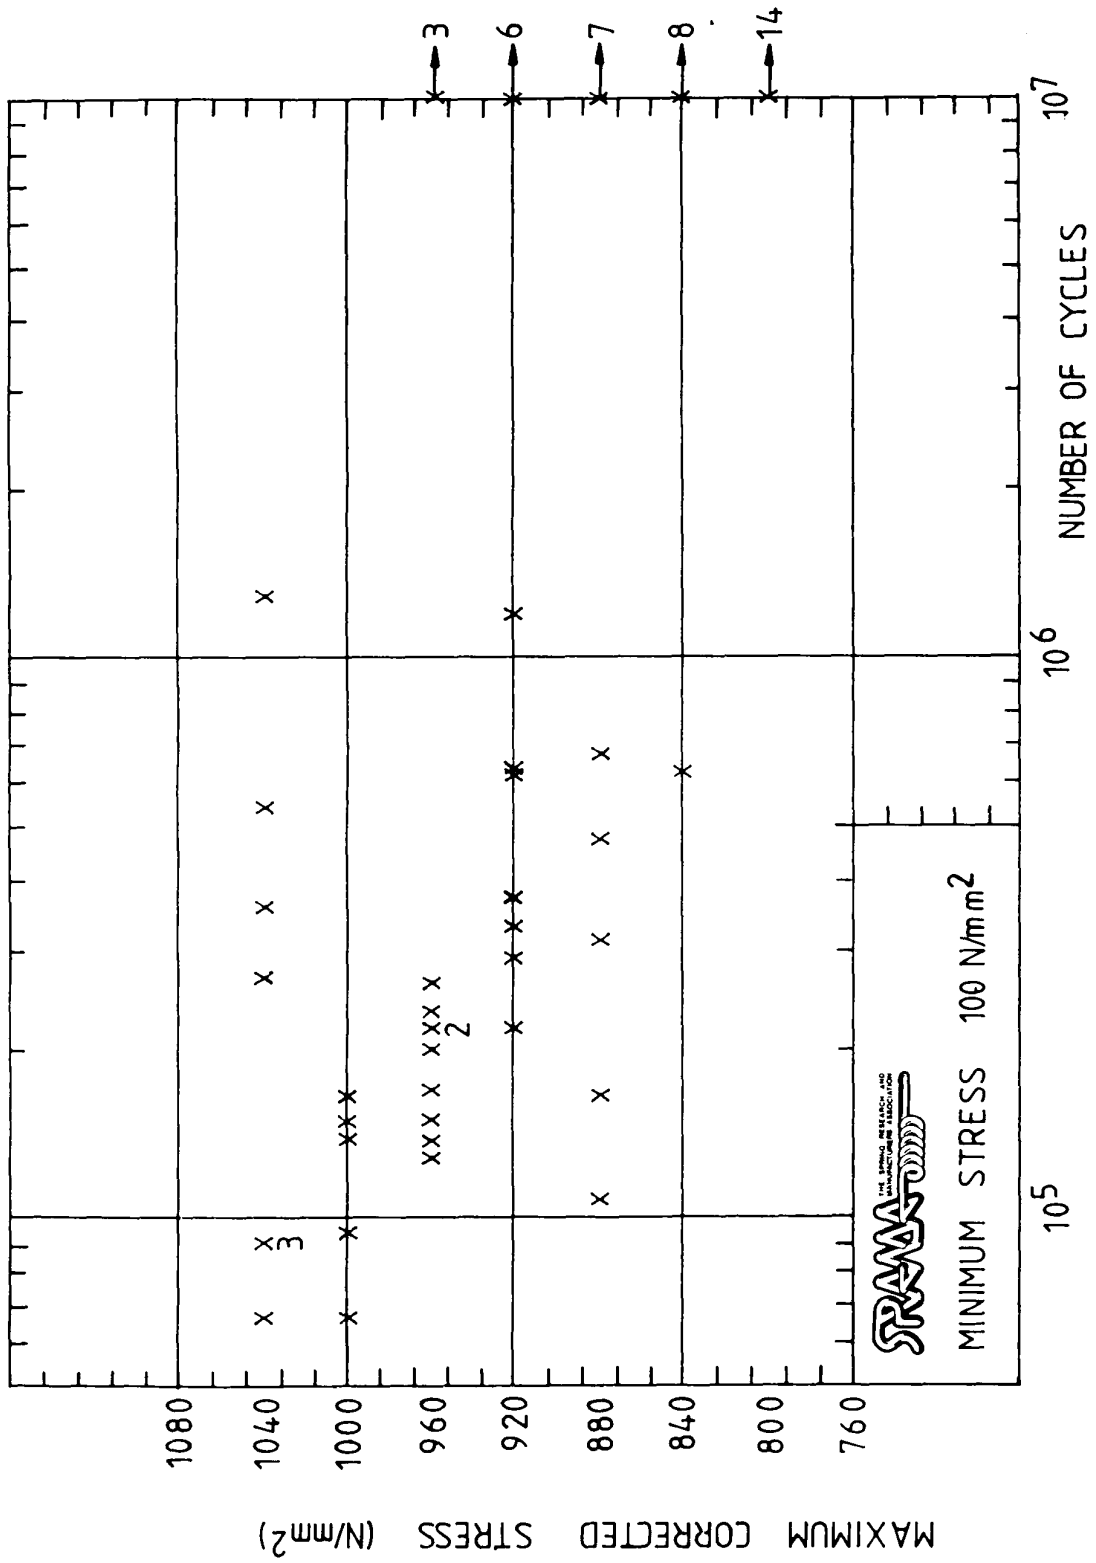
FIG.18. FATIGUE TEST RESULTS: BS 2803 C OK SHOTPEENED.

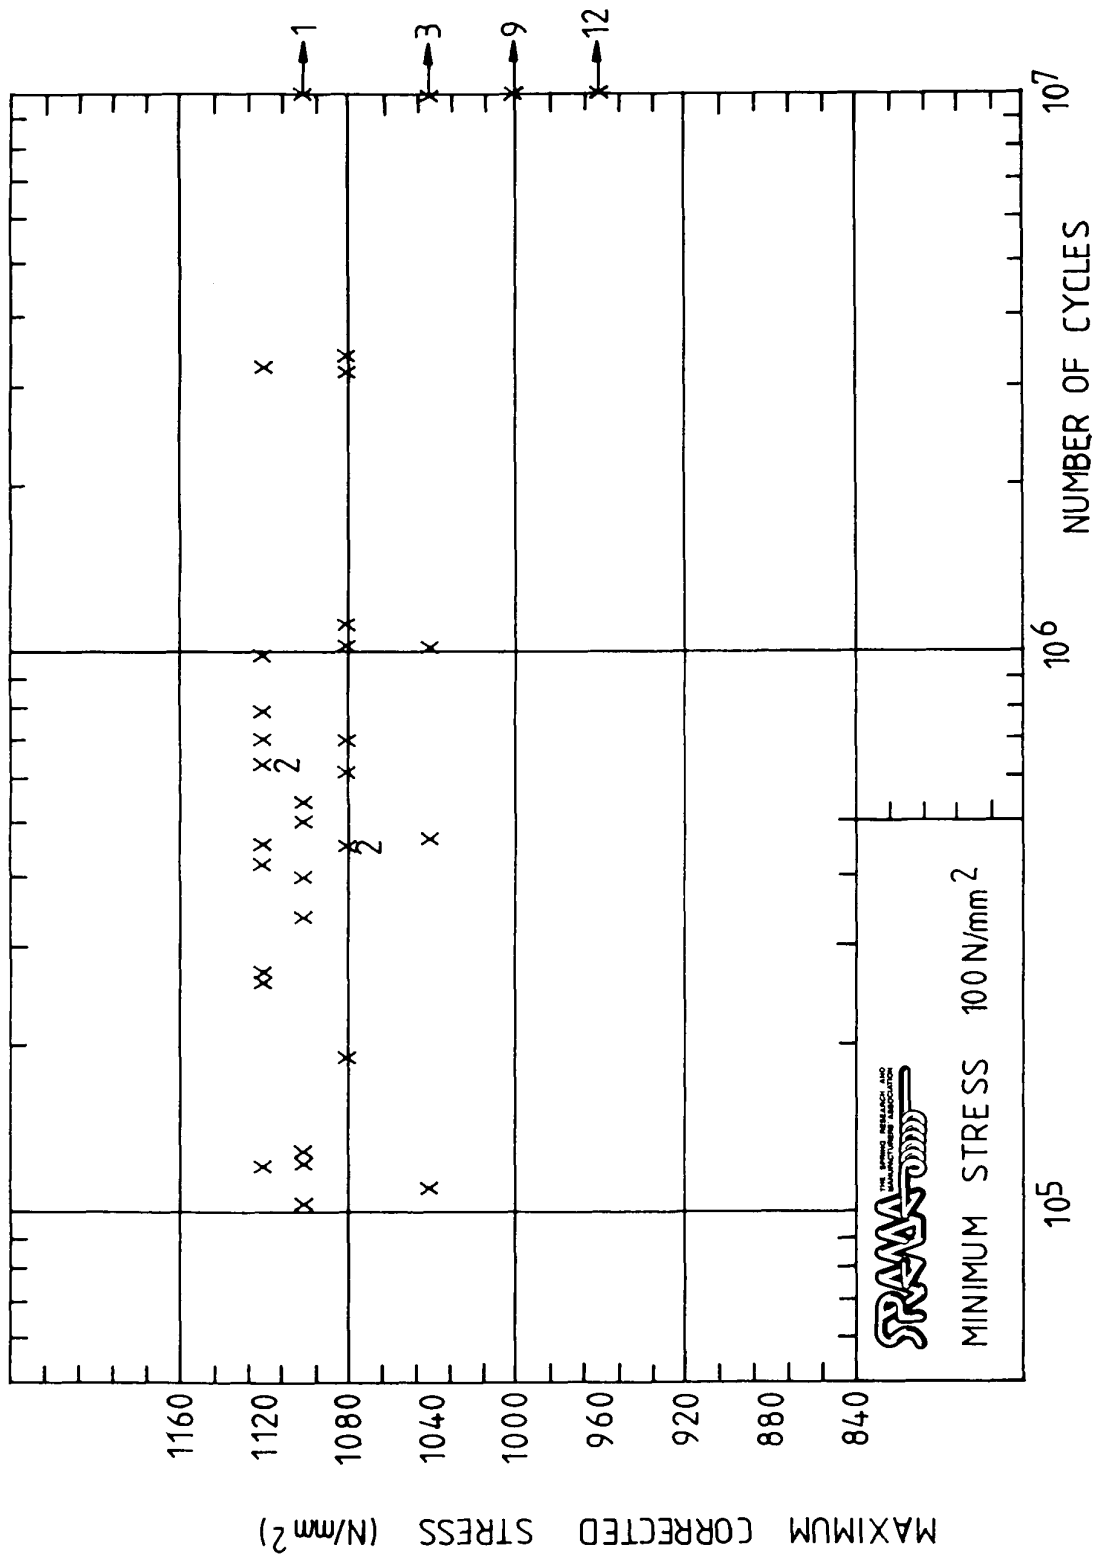
FIG 34. FATIGUE TEST RESULTS: BS 2803 CrV SDF SHOTPEENED.
