THE EFFECT OF SURFACE ROUGHNESS, ELECTROPOLISHING AND SHOT PEENING ON THE FATIGUE PROPERTIES OF AUSTENITIC STAINLESS STEEL SPRINGS

Report No 369

THE SPRING RESEARCH AND MANUFACTURERS' ASSOCIATION

MARCH 1984

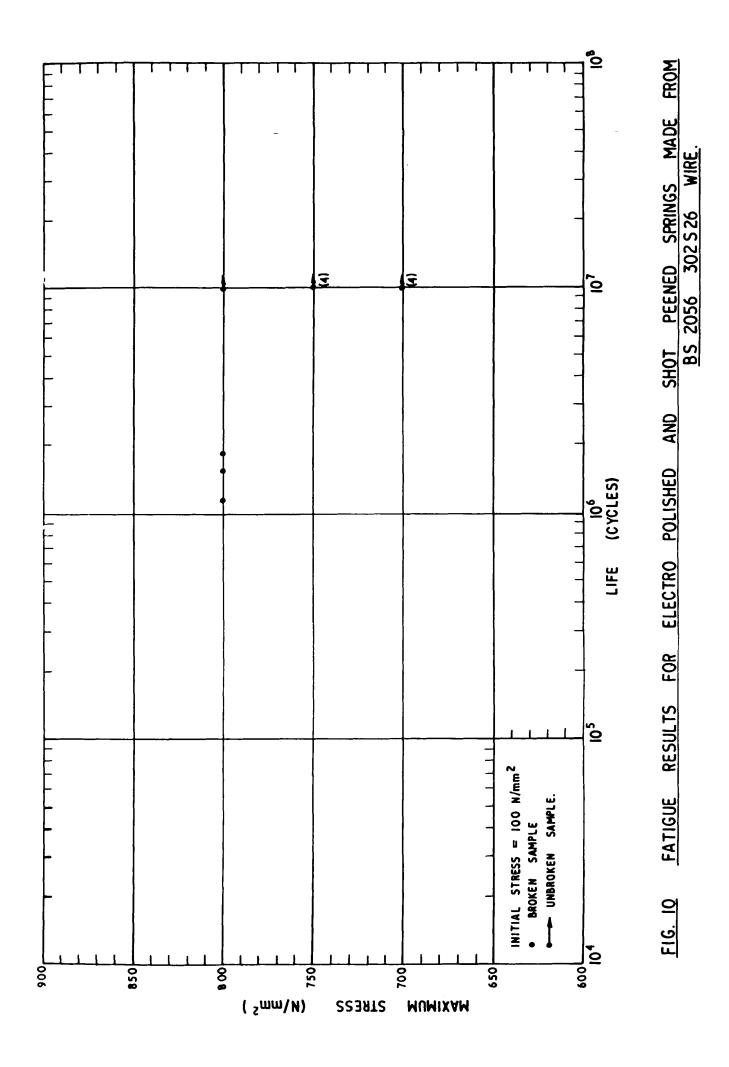
As all the failures in the electropolished springs were associated with the coiling mark on the wire surface, further testing of defect free electropolished springs could indicate whether the maximum benefits of this process have been realised.

Fatigue fracture of electropolished spring
